# Tsunami Runup Survey along the Southeast Indian Coast

## TSUNAMI SURVEY

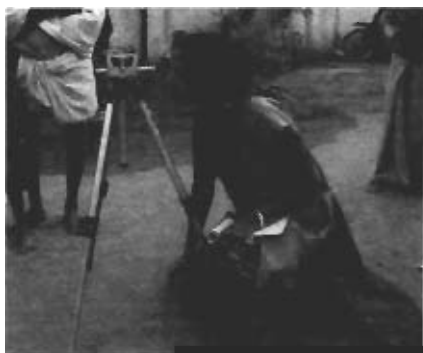
Figure 2. Sighting the runup elevation with the hand-level on a tripod.

Tsunami runup heights and distances were measured by using simple surveying hand-levels, staffs, and tapes (Figure 2). Vertical elevations of the runup marks were measured from mean sea level at the time of the measurements by noting the measurement time and location (Figure 3). After the survey, the measured runup heights were converted to values of runup at the time of the tsunami attack. This conversion was made on the basis of tide level corrections between the time of measurement and the time of the tsunami attack. Every tsunami mark used for the runup measurement was photographed for archiving, and its location was identified by a global positioning system (GPS). Because of the uncertainties involved in even carefully measured data, we anticipate an approximate 25-cm range of potential error in runup heights.

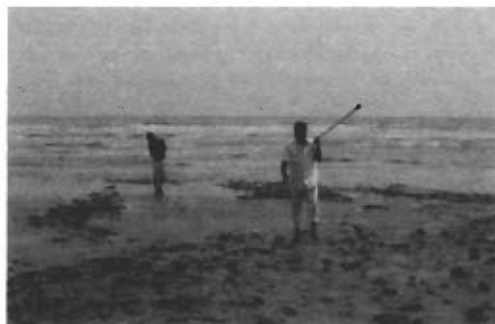
Figure 3. The mean sea level is used as the datum for the runup measurement (Arcattuthurai,  $10^{\circ} 23.612' N$ ,  $79^{\circ} 52.014' E$ ).

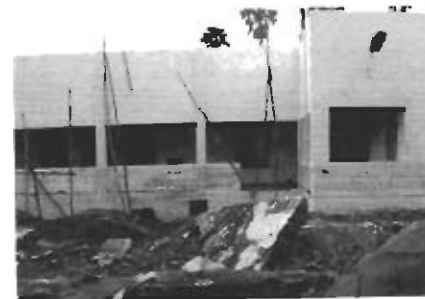
Figure 4. The mud line on the building wall is used as a reliable tsunami inundation level (Pekkalapet,  $12^{\circ} 01.708' N$ ,  $79^{\circ} 51.950' E$ ).

Tsunami runup marks were identified by the following observations. Flooding mud watermarks on structural walls are considered reliable evidence of runup height (Figure 4). Such a watermark in a protected area (e.g., inside a house) may be considered the "true" runup height or inundation level (Figure 5). That is because such marks represent flowing water depths that are generally devoid of turbulent surge or splashup. Accumulated marine-origin objects are also considered another type of reliable runup mark (Figure 6).

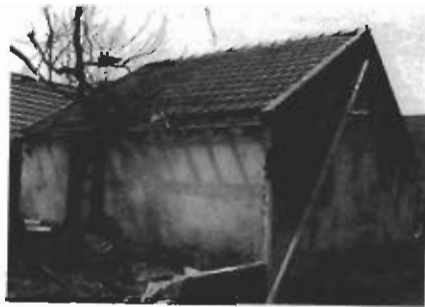
**Figure 7.** The scratch mark and roof tile damage are used as the estimate of tsunami inundation (Devanaapattinam,  $11^{\circ} 44.567' N$ ,  $79^{\circ} 47.317' E$ ).

Other types of runup marks are (1) scratch marks on buildings or tree trunks caused by the collision of waterborne objects (Figure 7) and (2) unusual materials found at abnormal locations, such as seaweed on tree branches or a fishing net clinging to a roof, as shown in Figure 8. Those tsunami marks are probably affected by local splashup action

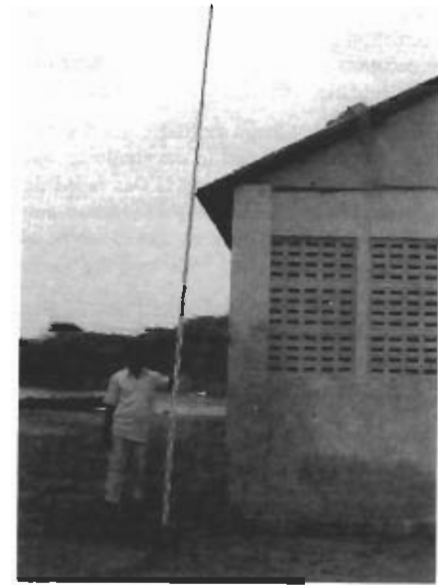
**Figure 8.** A piece of fishing net clinging to the roof is another type of tsunami mark (Nagapattinam,  $10^{\circ} 45.785' N$ ,  $79^{\circ} 50.928' E$ ).

and should not be considered reliable evidence of true inundation elevations. In fact, the elevation of the fishing net shown in Figure 8 was approximately 2 m higher than the watermark level found inside a building that was only 20 m away. It is noted that, upon arriving at several tsunami sites, we found recently hand-drawn signs indicating the tsunami levels (Figure 9); evidently, a local survey team must have made those marks prior to our arrival. Those elevations were measured and included in our data.

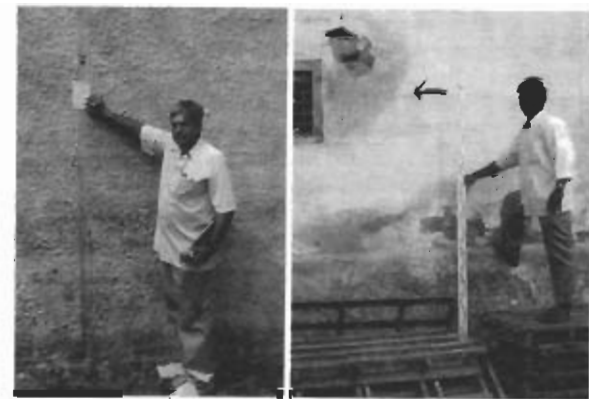
**Figure 9.** The signs of tsunami inundation levels found on the building walls (Kalapakkom,  $12^{\circ} 30.327' N$ ;  $80^{\circ} 09.600' E$  and Nagapattinam,  $10^{\circ} 46.477' N$ ,  $79^{\circ} 50.790' E$ ).

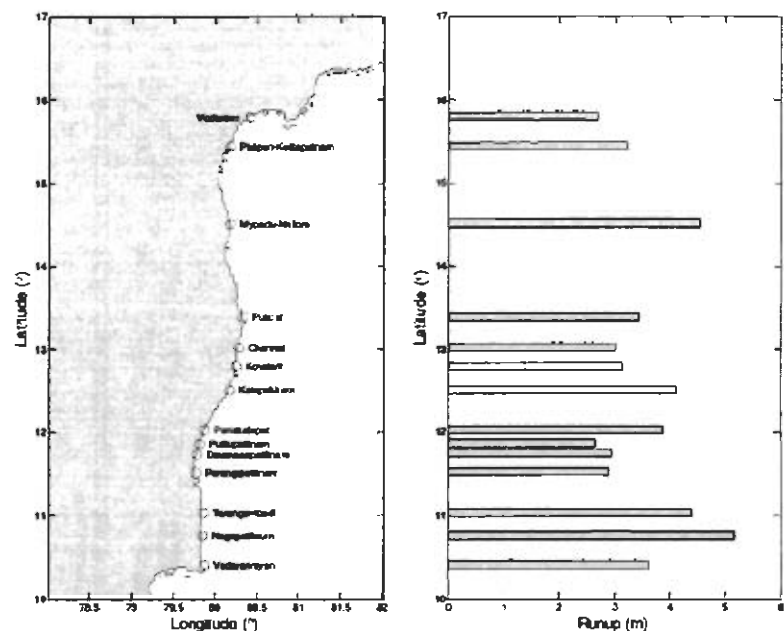
Figure 10. A plot of true inundation elevations along the southeast Indian coast.

Measured true inundation levels were plotted in Figure 10, showing fairly uniform runup heights (2.2–5.5 m) along the 600-km-long coast. The runup pattern exhibits no clear attenuation even at the most northern locale of the measurements ( $15^{\circ} 47.6' N$ ). In fact, runup elevations diminished little over the 250-km span of the northern survey, ranging from 2.7 to 4.6 m, which is generally similar to the findings from the southern survey.

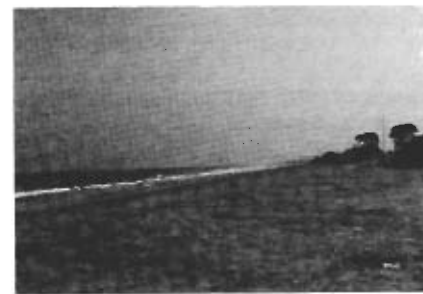
Figure 11. Typical coastal features in Southeast India (Pulicat,  $13^{\circ} 22.796' N$ ,  $80^{\circ} 20.009' E$ ).

The uniform tsunami runup distribution along the very long coastal stretch must be attributed to the very long tsunami source (approximately 1,000 km). Unlike the west coast of Thailand, the topography along the Indian coast is quite linear and open, as shown in Figure 11, without significant features of headlands, sounds, and coves. Furthermore, the very long incident tsunami length—approximately 430 km—tended to obscure significant local amplification within relatively small-scale detailed bathymetry variations.
